NRL/MR/6170--04-8762

Validation of HVOF WC/Co Thermal Spray Coatings as a Replacement for Hard Chrome Plating on Aircraft Landing Gear

March 31, 2004

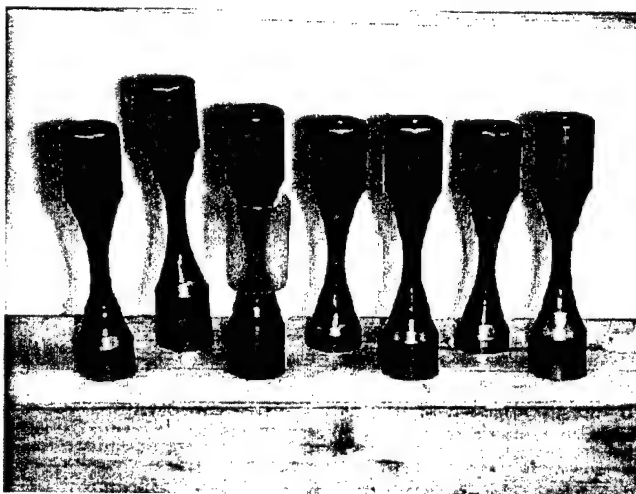
Figure 3-10. Small (1/4" dia) Hourglass Bars for Corrosion Fatigue Testing

The testing set-up is shown in Figure 3-10., Figure 3-11., and Figure 3-12.. These figures illustrate corrosion-fatigue testing, but the same arrangement was used for in-air testing (minus the stop-off paint and liquid receptacle).

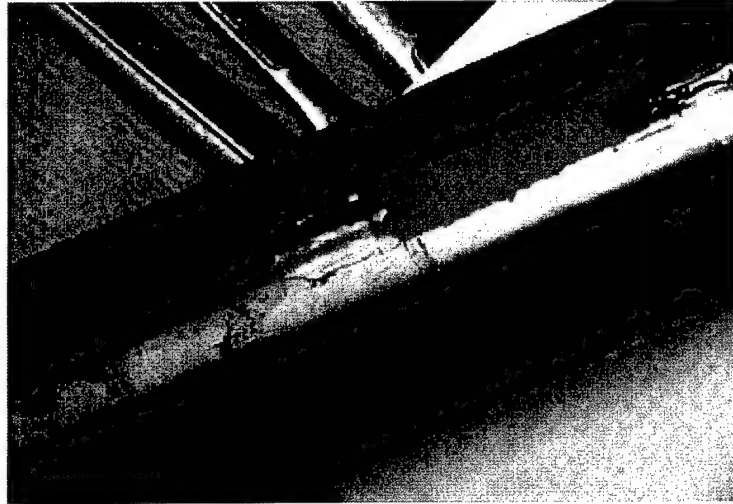
Figure 4-6. Spallation of a 0.015"-thick WC/CoCr Coating from a Test Cylinder (OO-ALC)

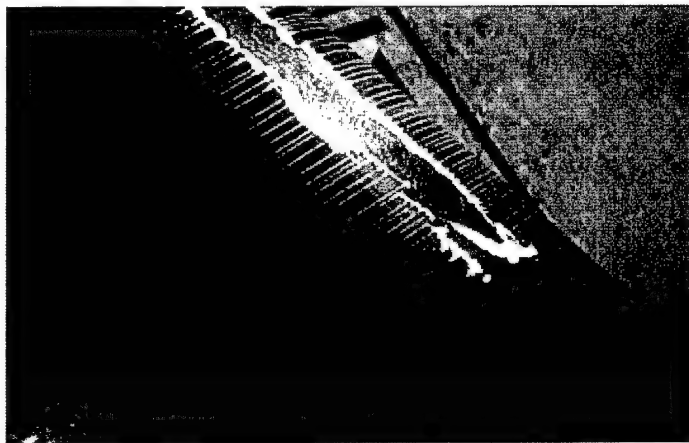
Figure 4-7. Same as Figure 4-6 , But Under FPI

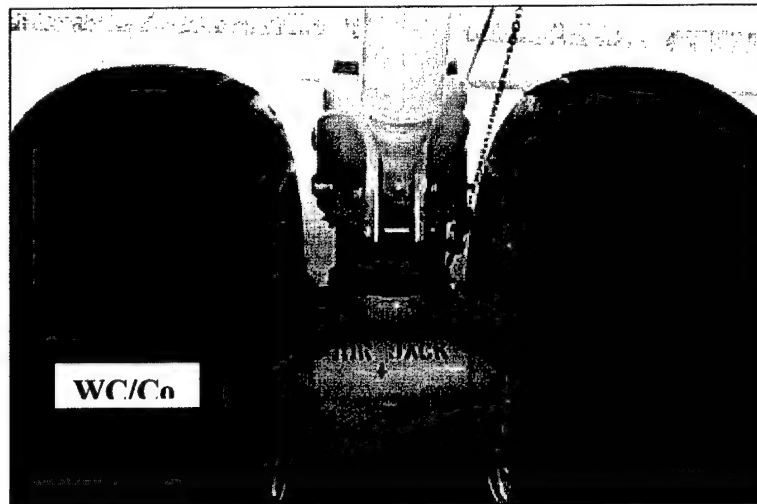
Figure 5-8. P-3C Main Landing Gear with HVOF WC/17Co-coated Piston Cylinder (indicated) and Axle Journals
